**2007 TAILINGS DAM INSPECTION  
SPANISH AMERICAN TAILINGS MANAGEMENT  
AREA**

Submitted to:  
Rio Algom Limited  
Elliot Lake Division  
P.O. Box 38  
Elliot Lake, Ontario  
P5A 2J6

April 2008

07-1118-073-4

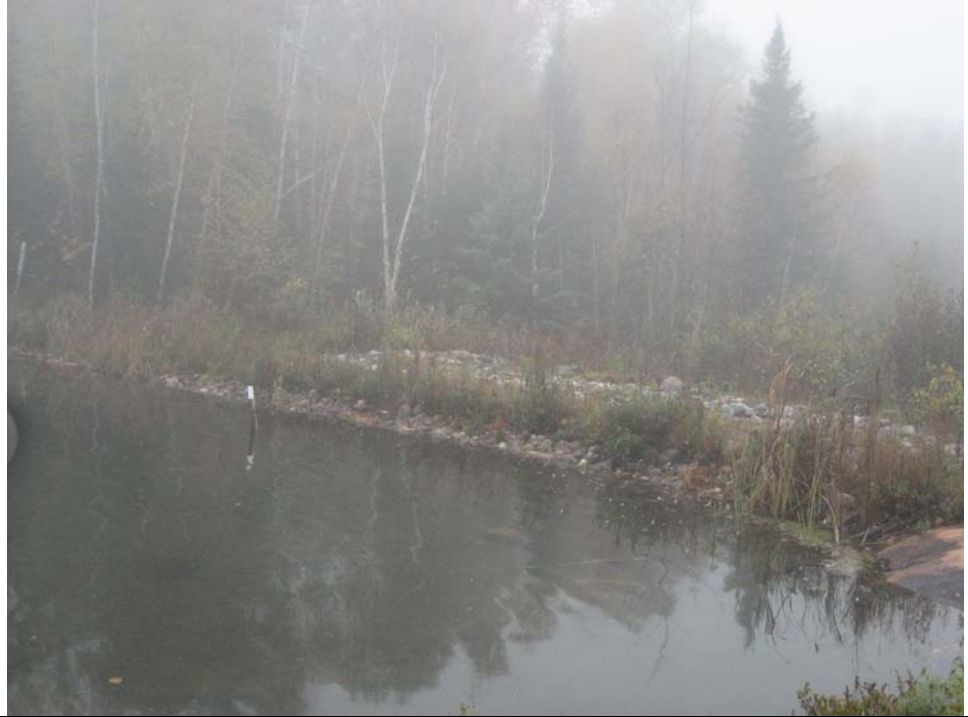
Photograph 1

At the time of the site visit the spillway on the South Berm was operating normally. There was no indication of beaver activity at the pond outlet.

Comments: No change in condition of spillway. Vegetation on spillway should be periodically cleared.

Upstream view of South Outlet Berm.

The vegetation on the berms especially on the spillway inlet will require should be cleared. As well some cutting of vegetation along the access road should also be carried out.

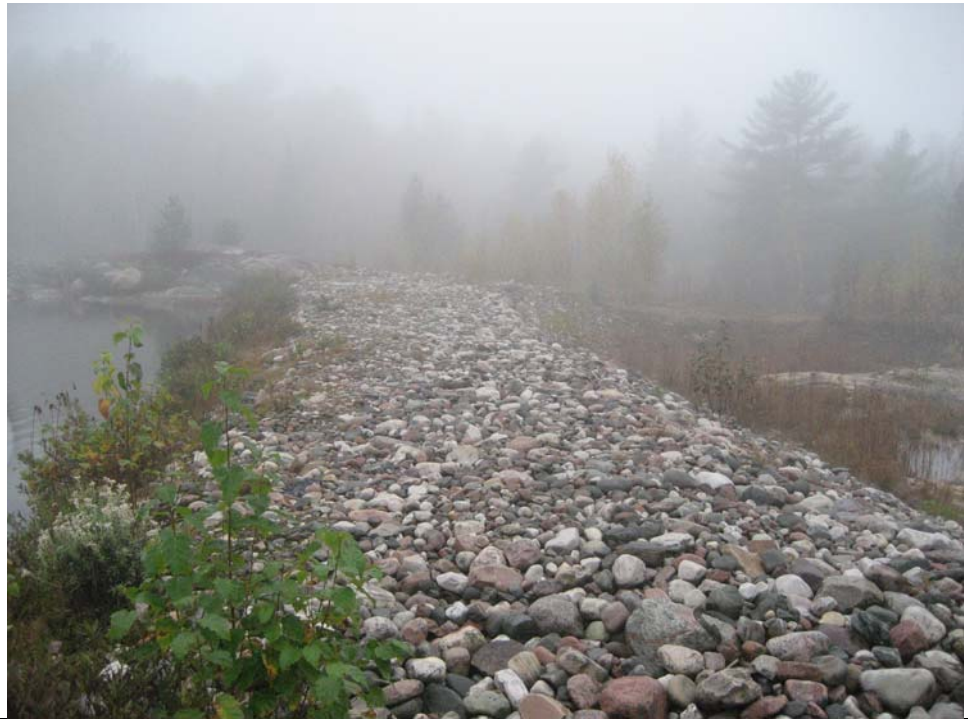
Photograph 2

cracking [x] none [ ]
settlement [x] none [ ]
erosion [x] none [ ]
other movement [x] none [ ]
crest vegetation [ ] none [x] Shrubs and grass on both berms

*The berms have remained in good working condition. The vegetation on spillway and berm should be cleared.*

North Outlet Berm crest.
